A Mitigator Describes A “House from Radon Heck”

This year's AARST Symposium introduced what turned out to be an exceedingly popular and well-received segment: ^aHouses from Radon Heck.^o Mitigators and other radon professionals empathized and identified with the experiences presented by a panel of respected radon mitigators that included Jay Brown, Gary Hodgden, Deane Mickle and Jack Hughes. The following is an excerpt from Jay Brown's ^aHouses from Radon Heck.^o

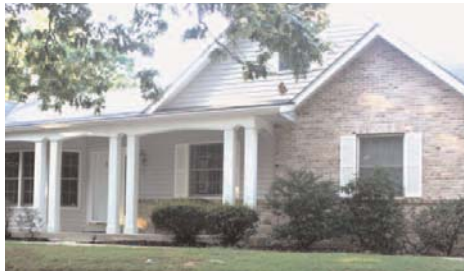
On a dark winter evening early in my career, I was called to submit a radon mitigation proposal for this home. The radon level was reported to be 7.6 pCi/L.

The bay window was cantilevered over dirt. The basement directly communicated with the void under the front porch. Under just the right meteorological conditions the house inhaled a huge whiff of radon-laden air from under the porch, then started inhaling fresh air.

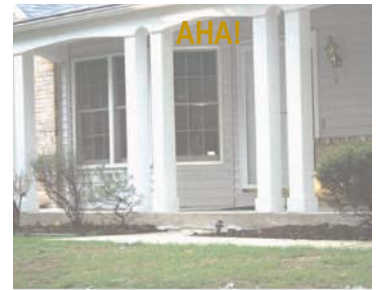
System installation and post-mitigation test results

The diagnosis demonstrated excellent sub slab communication. However, it had a pretty strong stack effect for such a low radon level. We got the job and installed a standard sub slab mitigation system. We retested and the results were comfortably below our guarantee of less than 2.0 pCi/L.
