# A Mitigator Describes A “House from Radon Heck”

This year's AARST Symposium introduced what turned out to be an exceedingly popular and well-received segment: <sup>a</sup>Houses from Radon Heck.<sup>o</sup> Mitigators and other radon professionals empathized and identified with the experiences presented by a panel of respected radon mitigators that included Jay Brown, Gary Hodgden, Deane Mickle and Jack Hughes. The following is an excerpt from Jay Brown's <sup>a</sup>Houses from Radon Heck.<sup>o</sup>

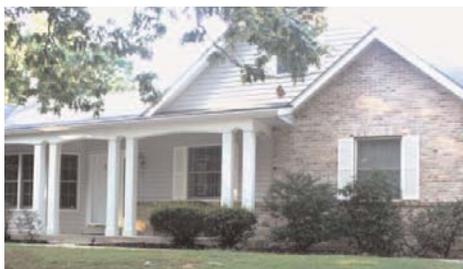
On a dark winter evening early in my career, I was called to submit a radon mitigation proposal for this home. The radon level was reported to be 7.6 pCi/L.

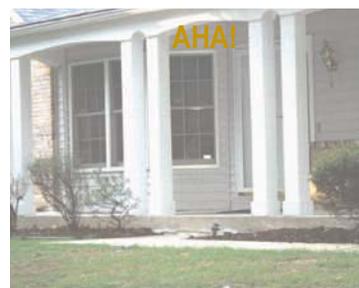
The bay window was cantilevered over dirt. The basement directly communicated with the void under the front porch. Under just the right meteorological conditions the house inhaled a huge whiff of radon-laden air from under the porch, then started inhaling fresh air.

We closed the band joist area and installed two suction drops through the foundation wall to address the void under the porch.

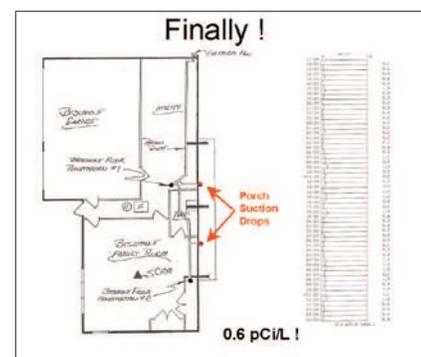
The radon level soared from 0.1 pCi/L up to 240.7 pCi/L then decayed logarithmically to 0.8 pCi/L

After we sent the final report to the Realtor he said the relocation company did a lot of testing. I asked if he had copies of the tests.
